**[8] SELF DIAG AND TROUBLE CODE**

**1. Self diag**

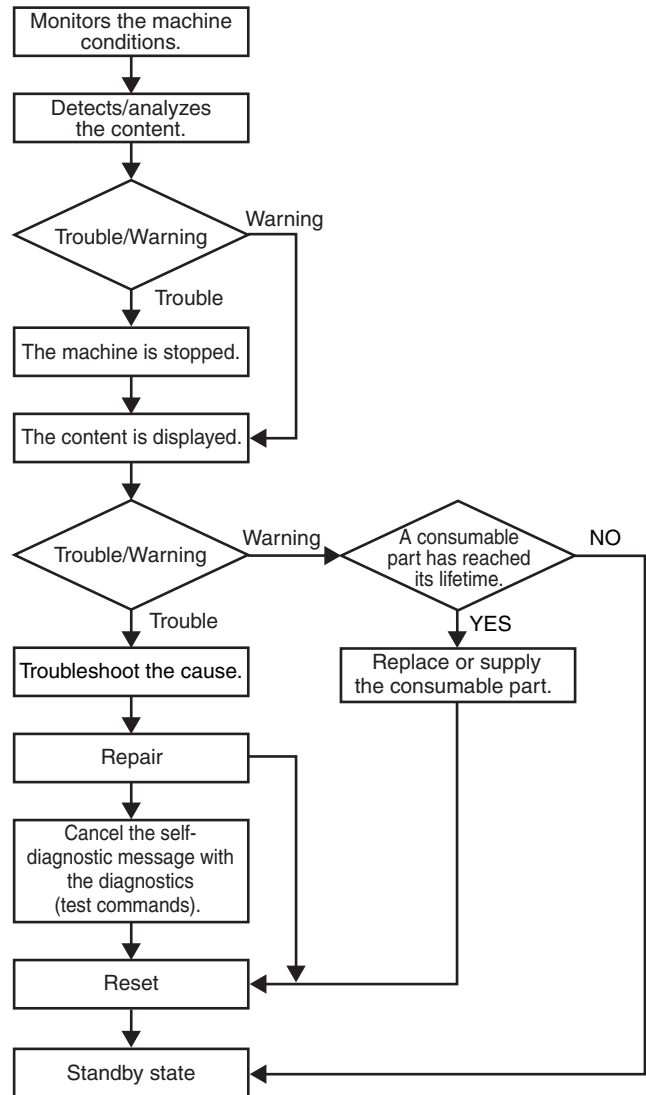
**C. Self diag operation and related work flow**

The machine always monitors its own state.

Some trouble messages are automatically cleared when the trouble is repaired. Some other troubles must be cleared by a simulation.

Some warning messages of consumable parts are automatically cleared when the trouble is repaired. Some other warning messages must be cleared by a simulation.
